# Cyclone Seroja at Yarragadee Geodetic Observatory

## Preparation and Effect

Randall Carman | YGO team

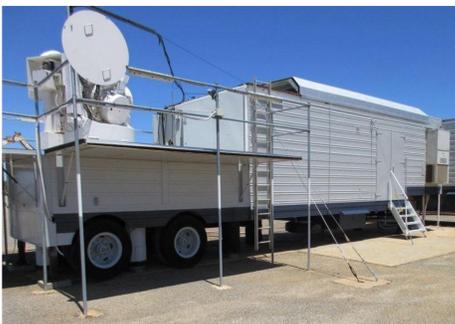
Figure 3: New tie down cables installed on NASA MOMS van

At Yarragadee, we checked and tightened all tie down cables and replaced any defective or missing ones. Fortunately, we had concrete anchor points installed because of previous cyclones in the late 70's. The two NASA vans were well tethered in all directions except for the MOMS van to the east. As for the VLBI dish, it was decided we did not have time (an EWP would be needed) to tie the 12m main reflector to its anchor footings. Since the dish was designed to withstand 100 mph winds in stow, untethered, and the cyclone was expected to weaken rapidly once it crossed the coast, we felt ok with that.

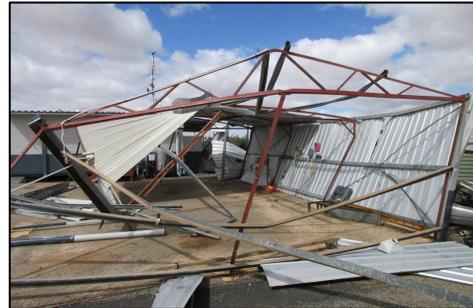
Figure 6: The carport was severely damaged

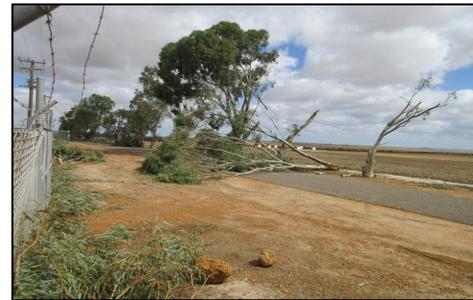
Figure 8: Hundreds of the trees nearby and much of our security fencing were damaged

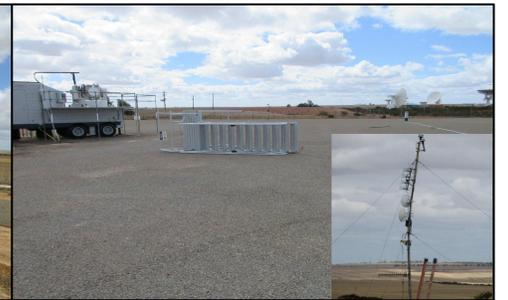
Figure 9: The MOMS van access stairs were moved but basically undamaged. Note the SSC/USN 13m dish forced down through hard limits in the background. Inset: The communications tower was slightly bent when the departing verandah struck it, but the two anemometers at the top functioned throughout

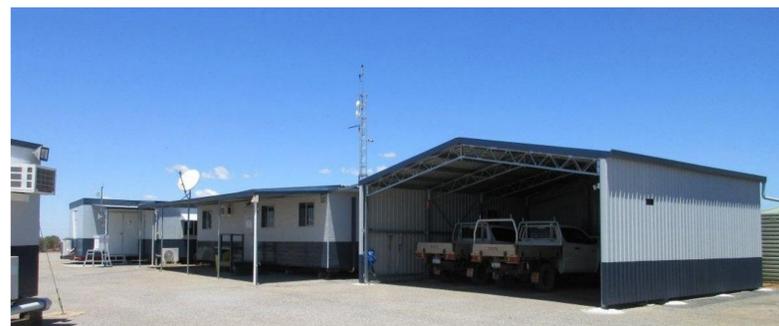
Figure 9: 18 months after Cyclone Seroja caused extensive damage to the infrastructure at YGO, repairs are almost complete. Note the new much improved communications tower with anemometers in place ready for the next big event. The new carport is cyclone rated.
